PROPERTY INSPECTION REPORT

Concerning: Somewhere in Texas, 7XXXX
(Address or Other Identification of Inspected Property)

By: Ronnie Wiggin #6321 /2005
(Name and License Number of Inspector) (Date)

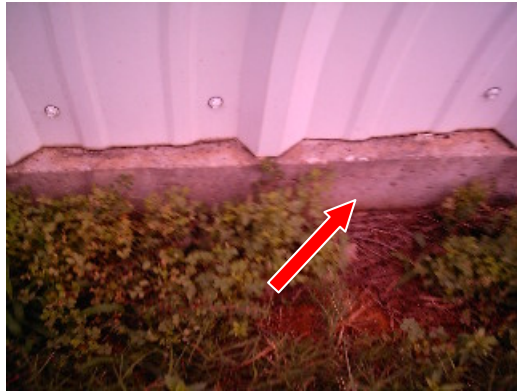
Common minor cracks were observed in the foundation walls of the house along the east side of the house. This implies that some structural movement of the building has occurred, as is typical of most houses.

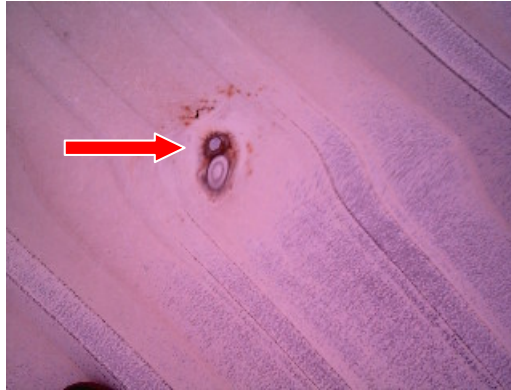
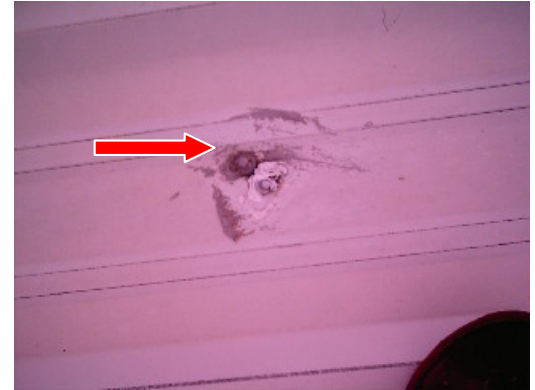
- Openings noted around screw heads at various locations and should be sealed

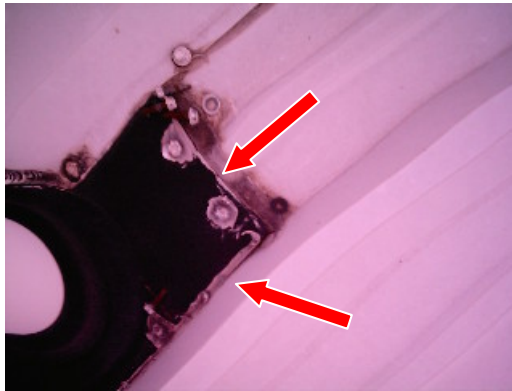
- Openings were noted around the plumbing vent boot and should be sealed

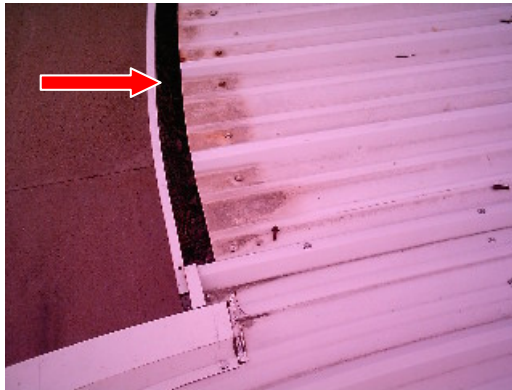
- Dirty rain gutters were observed along the rear/front slope and should be cleaned out to allow for proper drainage

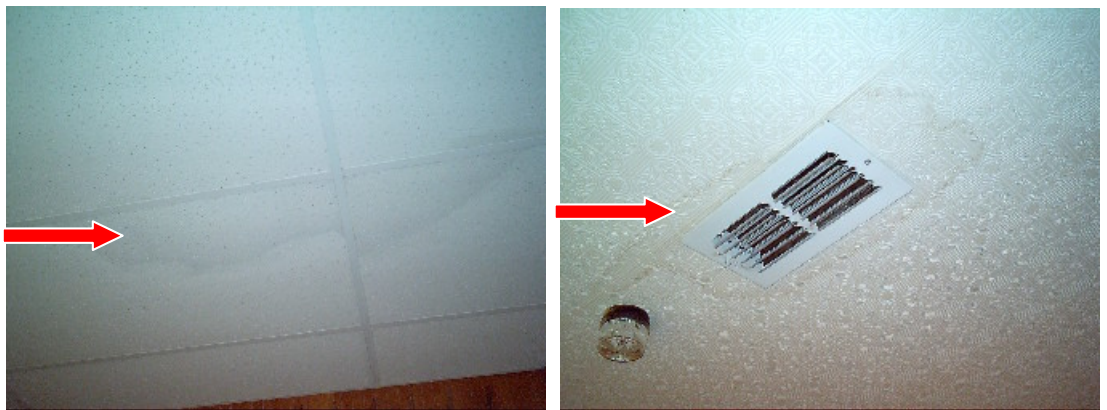
Previous water stained ceiling tiles were observed at various locations

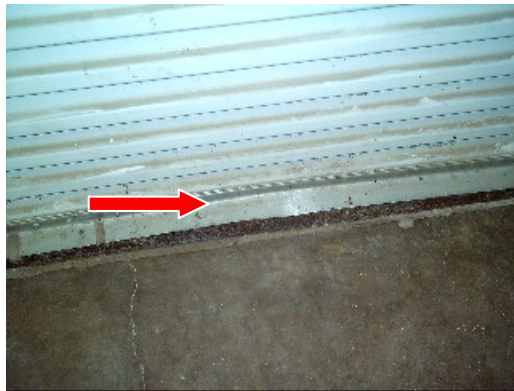
Damage was observed along the bottom of the center bay door making it difficult to open and close. Adjustments should be made to improve the operation

Damage was observed along the bottom of the center bay door making it difficult to open and close. Adjustments should be made to improve the operation

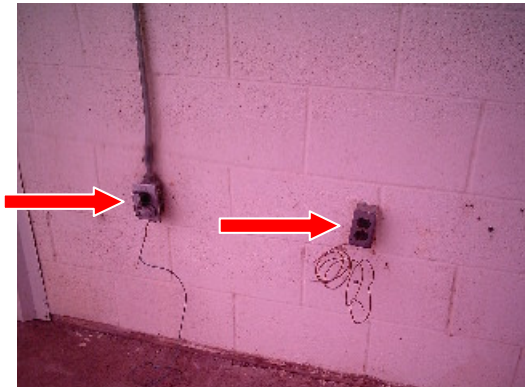
Ungrounded outlets were noted at the front of the building. Alternatively, a grounded cable could be strung to this outlet, or a separate ground wire could be connected. Some electrical codes allow the installation of a ground fault circuit interrupter (GFCI) type outlet where grounding is not provided.

Ungrounded outlets were noted at the front of the building. Alternatively, a grounded cable could be strung to this outlet, or a separate ground wire could be connected. Some electrical codes allow the installation of a ground fault circuit interrupter (GFCI) type outlet where grounding is not provided.

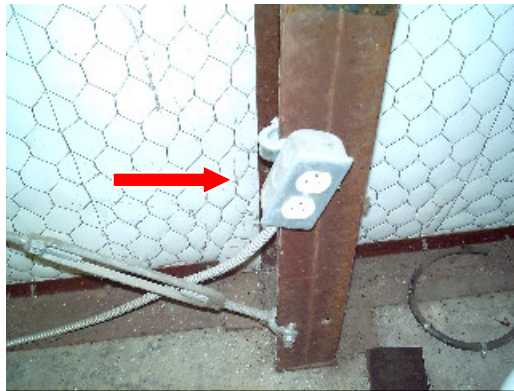
A poorly mounted outlet was observed along the east warehouse wall and should be improved

A poorly mounted outlet was observed along the east warehouse wall and should be improved

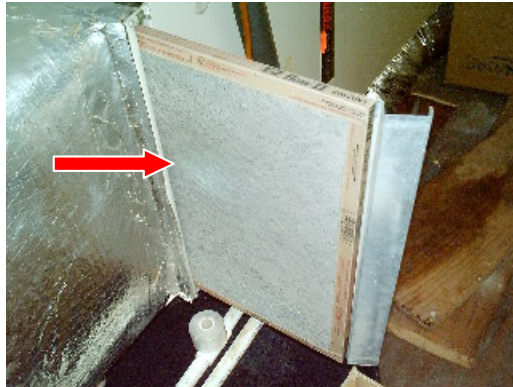
Dirty return air filters were noted and should be replaced. I always recommend the pleated style air filters that filter much better than the plain fiberglass type.

Dirty return air filters were noted and should be replaced. I always recommend the pleated style air filters that filter much better than the plain fiberglass type.

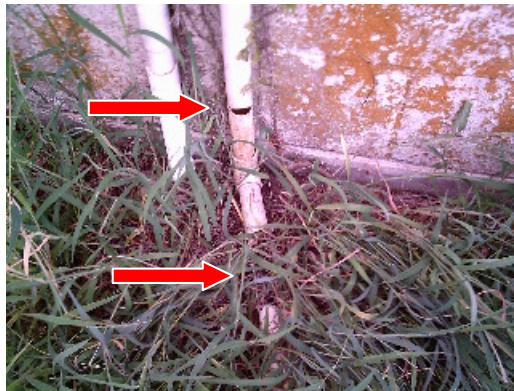
Damaged primary/secondary drain lines were observed along the north side of the building and should be repaired

Damaged primary/secondary drain lines were observed along the north side of the building and should be repaired

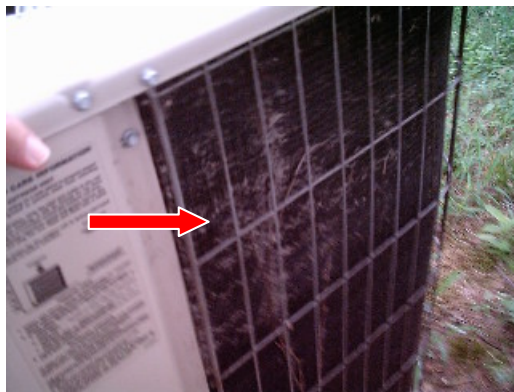
The outdoor unit(s) of the air conditioning system along the north side of the house requires cleaning.

The outdoor unit(s) of the air conditioning system along the north side of the house requires cleaning.

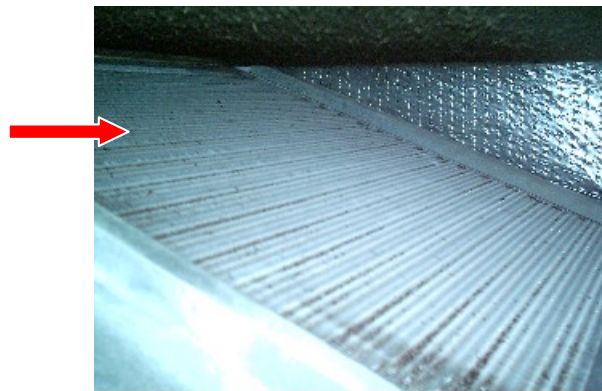
The evaporator coils of the east unit located in the attic area were observed to be minor dirty and should be further evaluated by a HVAC professional to determine if cleaning is needed

The evaporator coils of the east unit located in the attic area were observed to be minor dirty and should be further evaluated by a HVAC professional to determine if cleaning is needed
